REPORT ON FUEL-PLATE MELTING

AT THE OAK RIDGE RESEARCH REACTOR JULY 1, 1963

ORNL-TM-627

OPERATIONS DIVISION

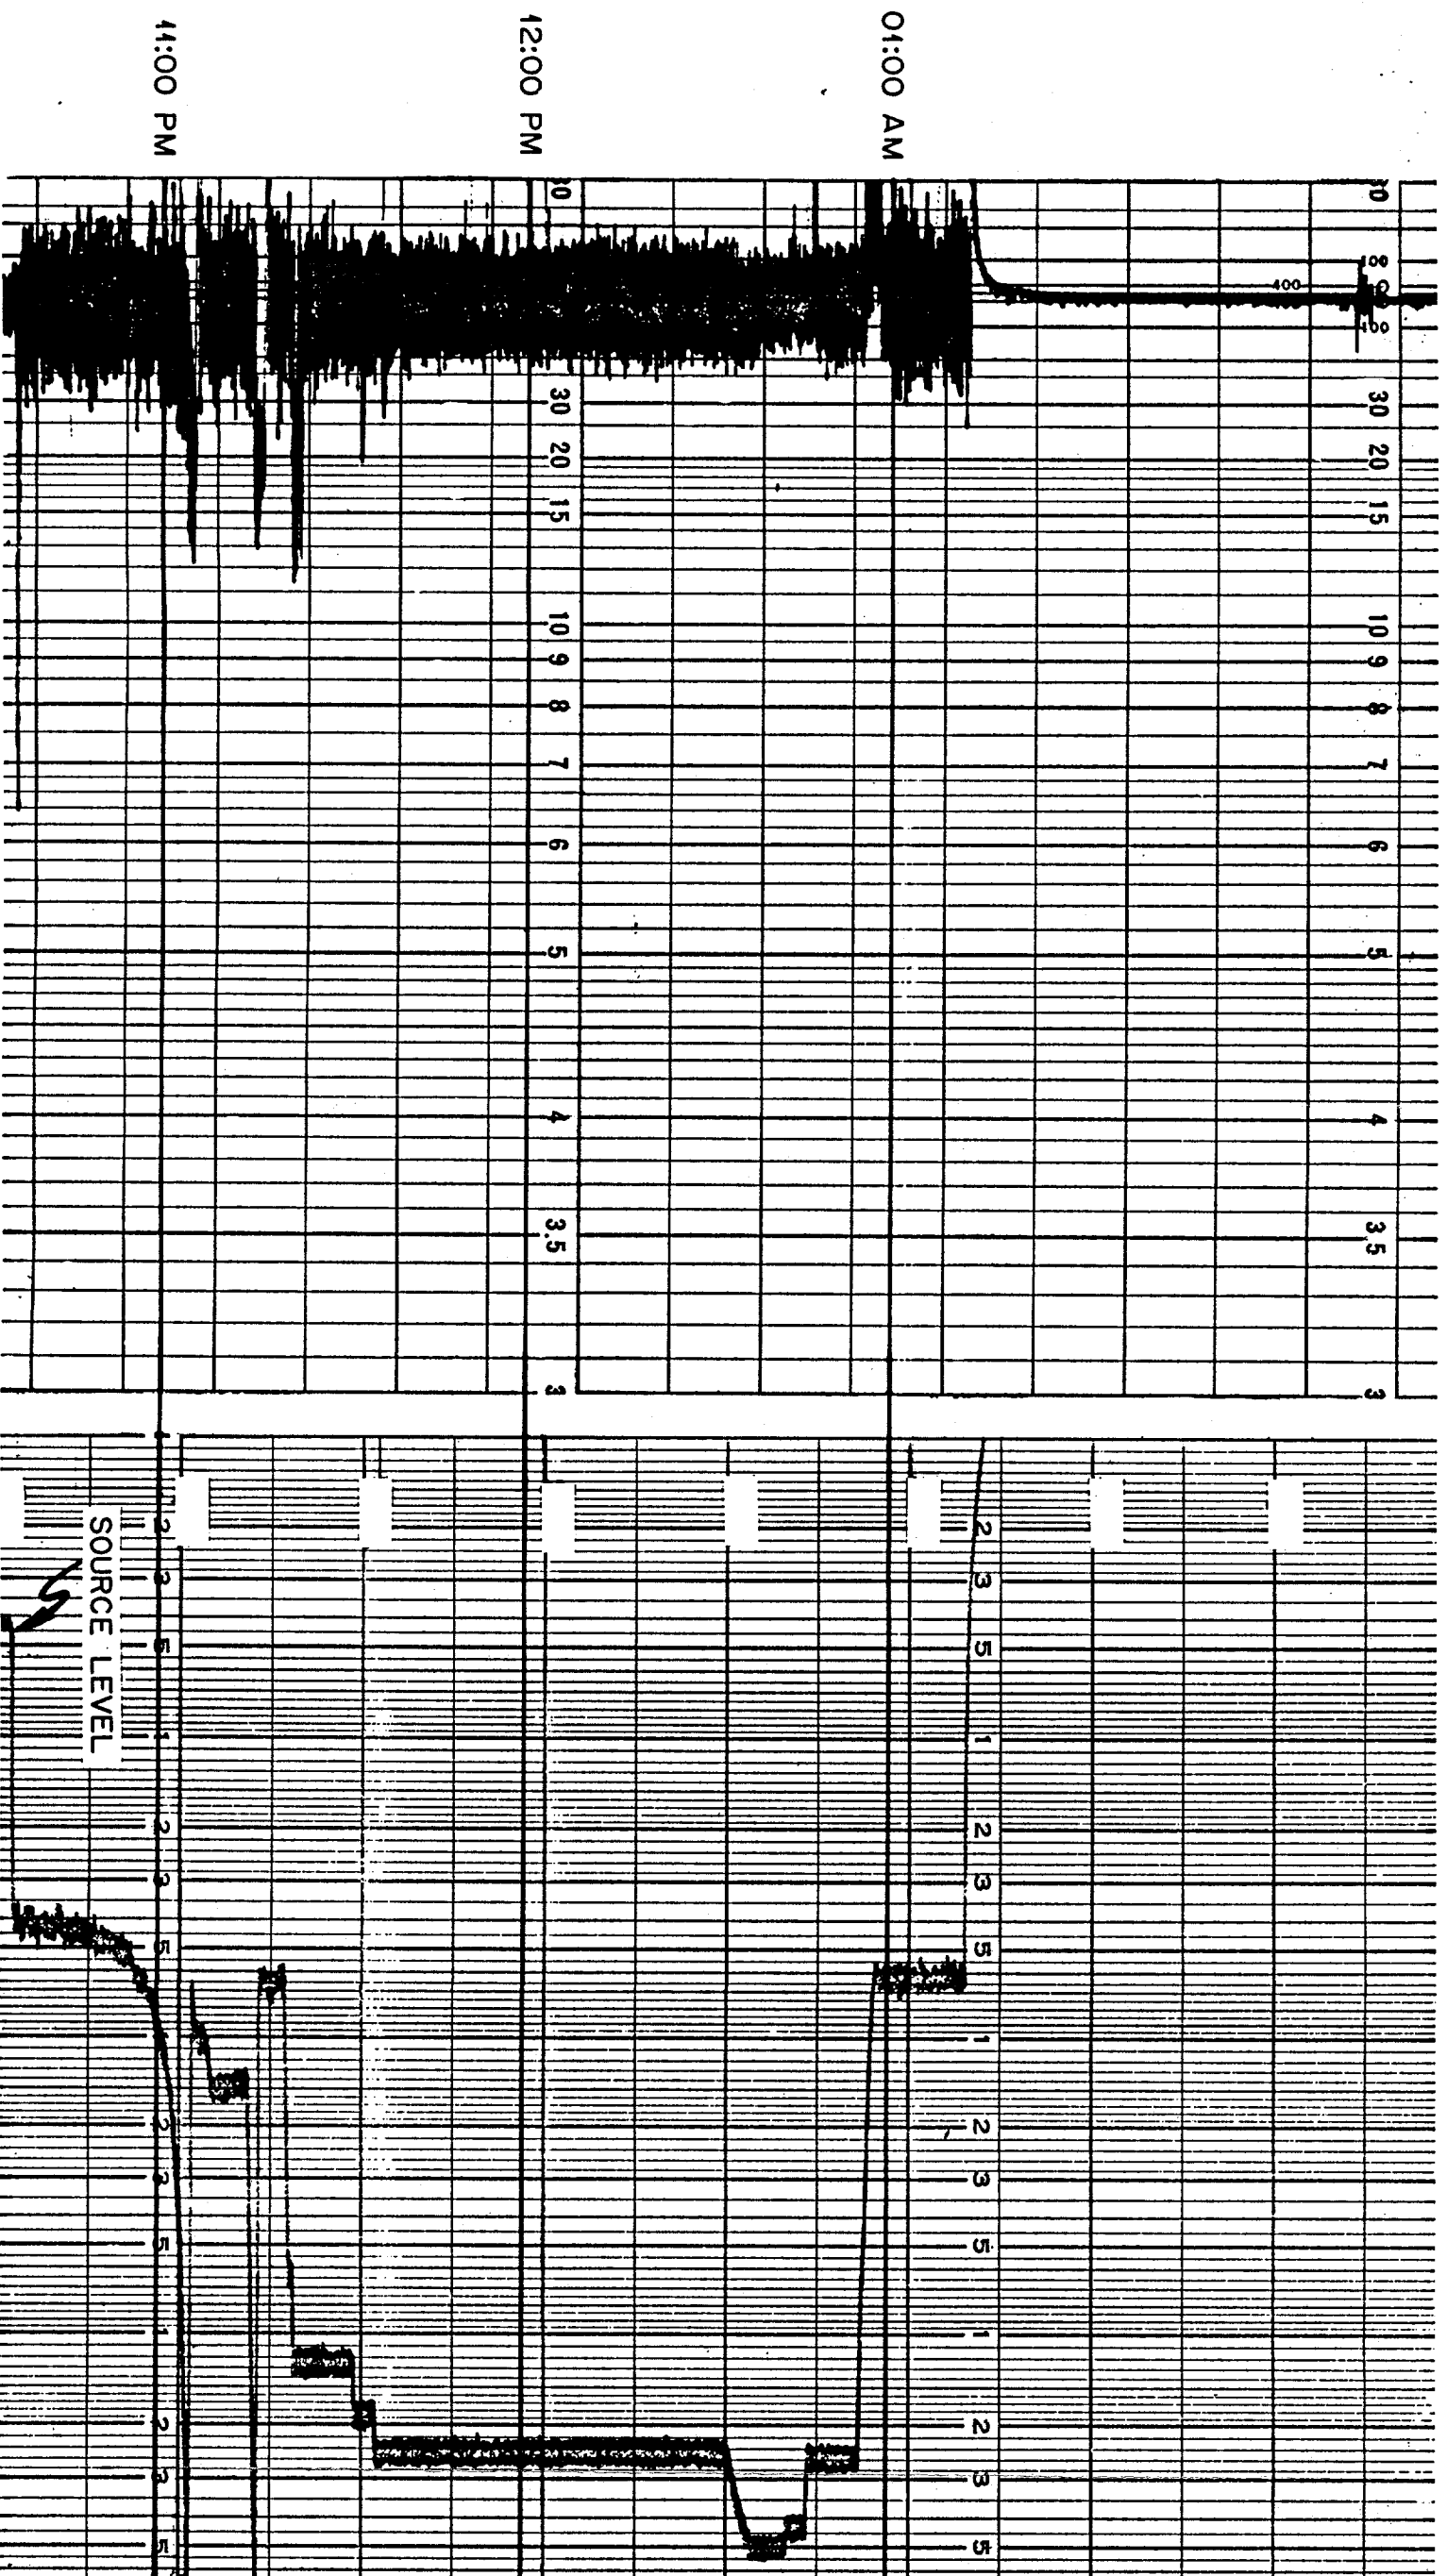
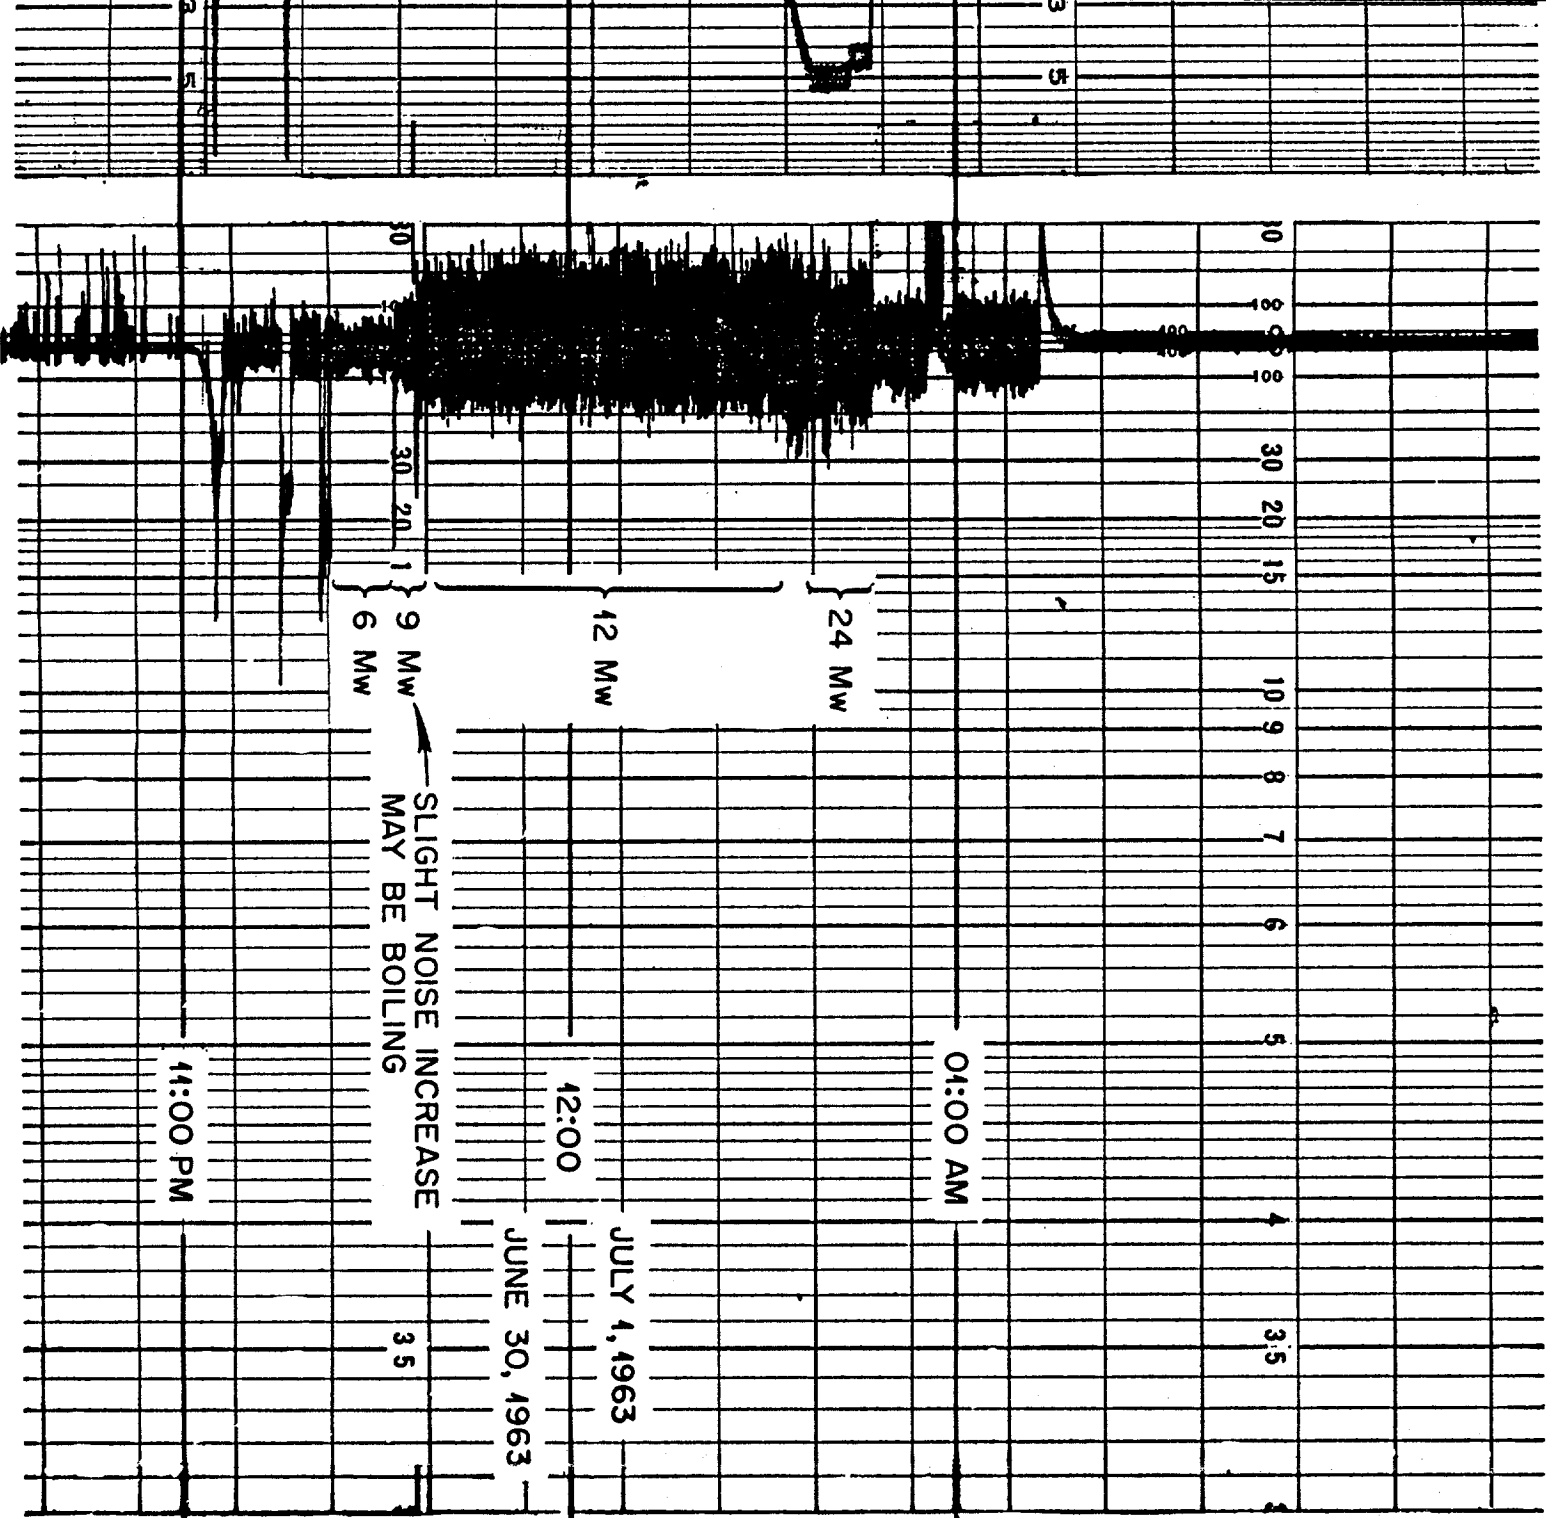
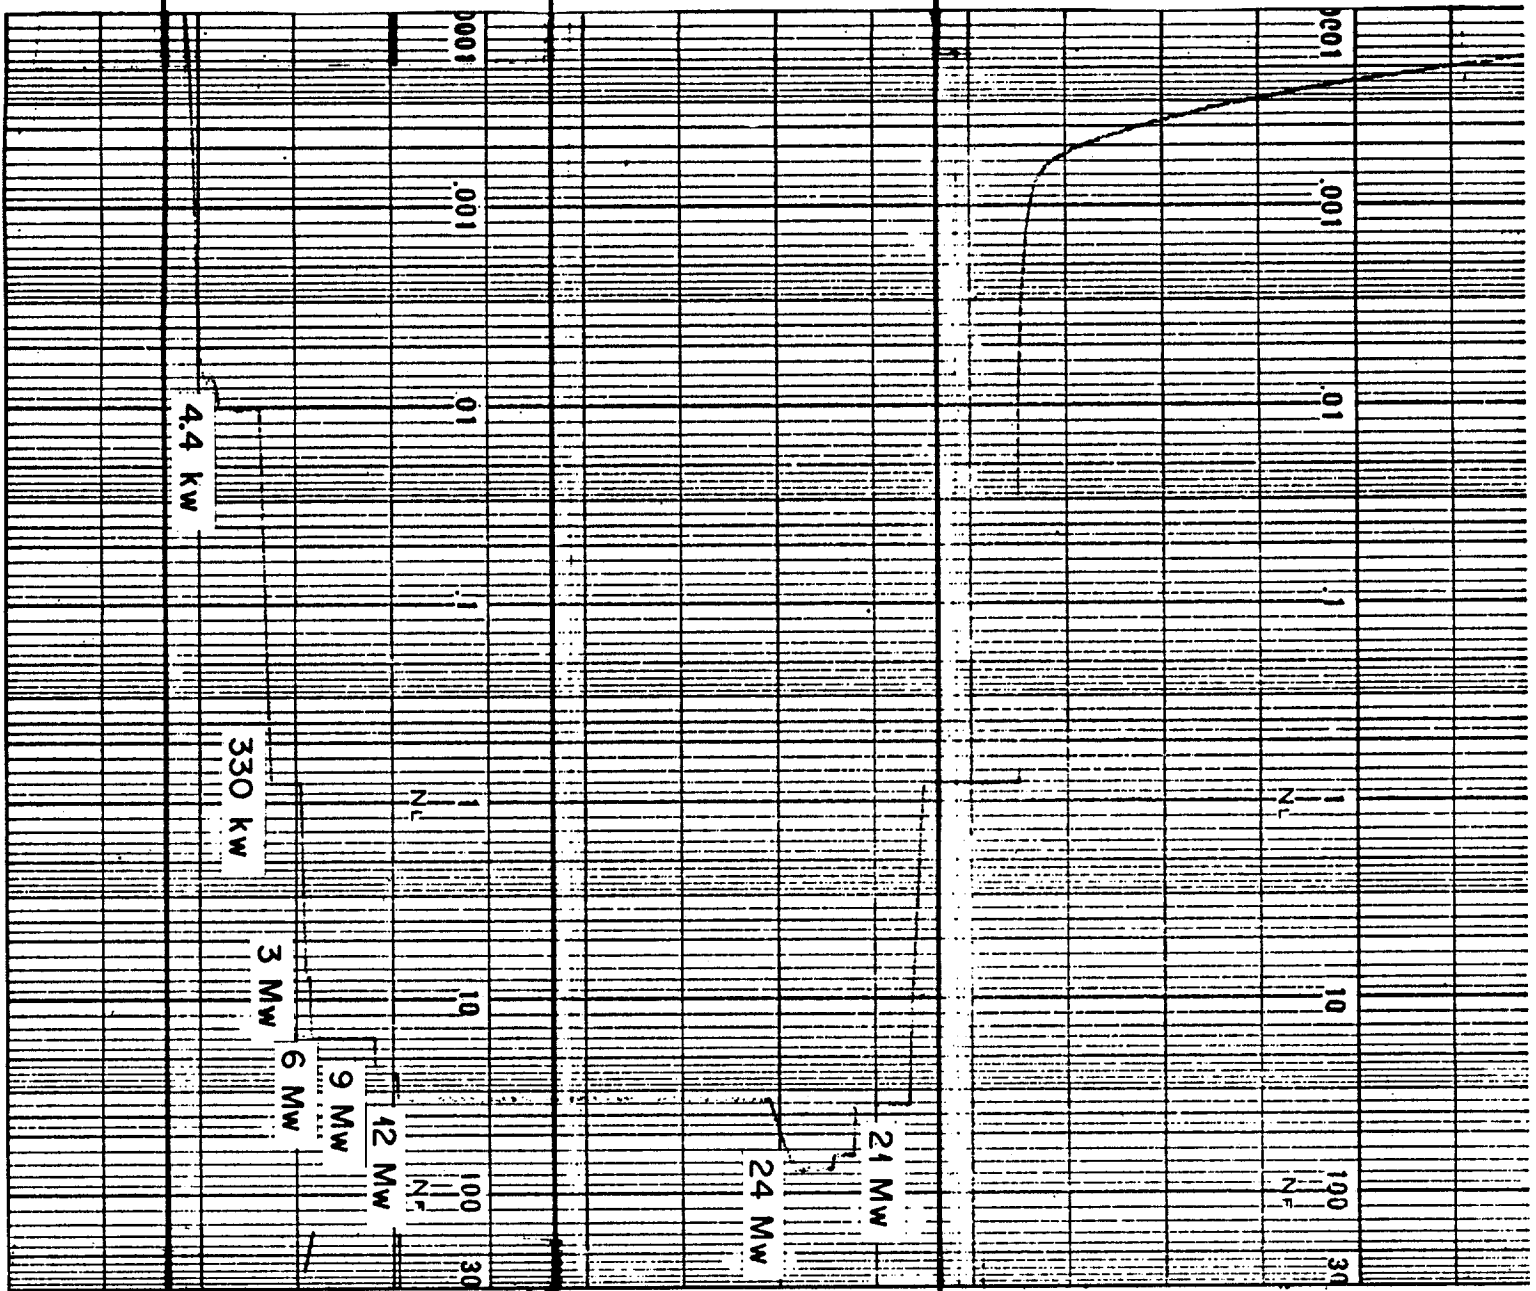
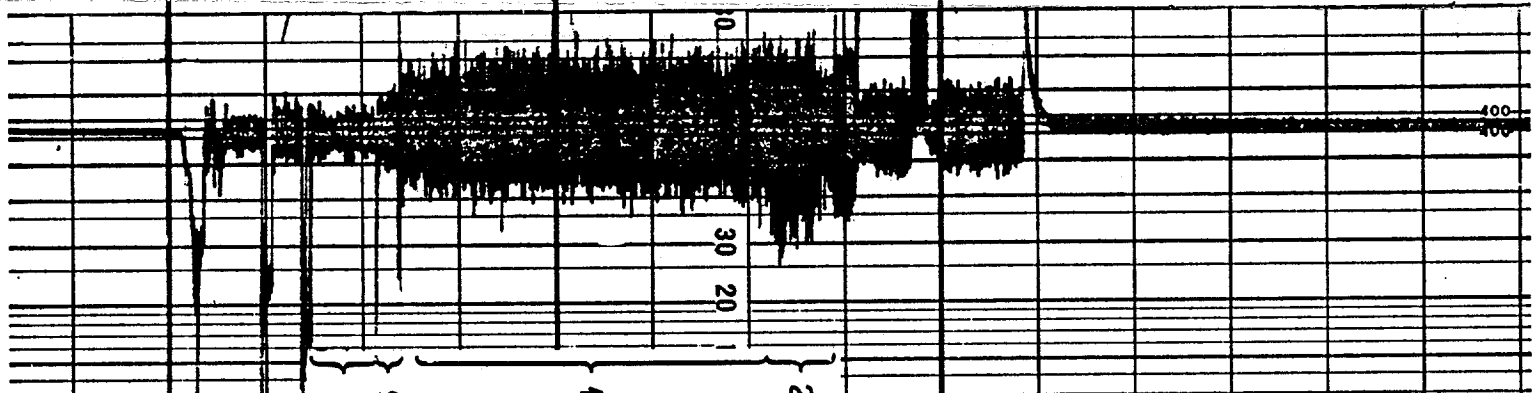
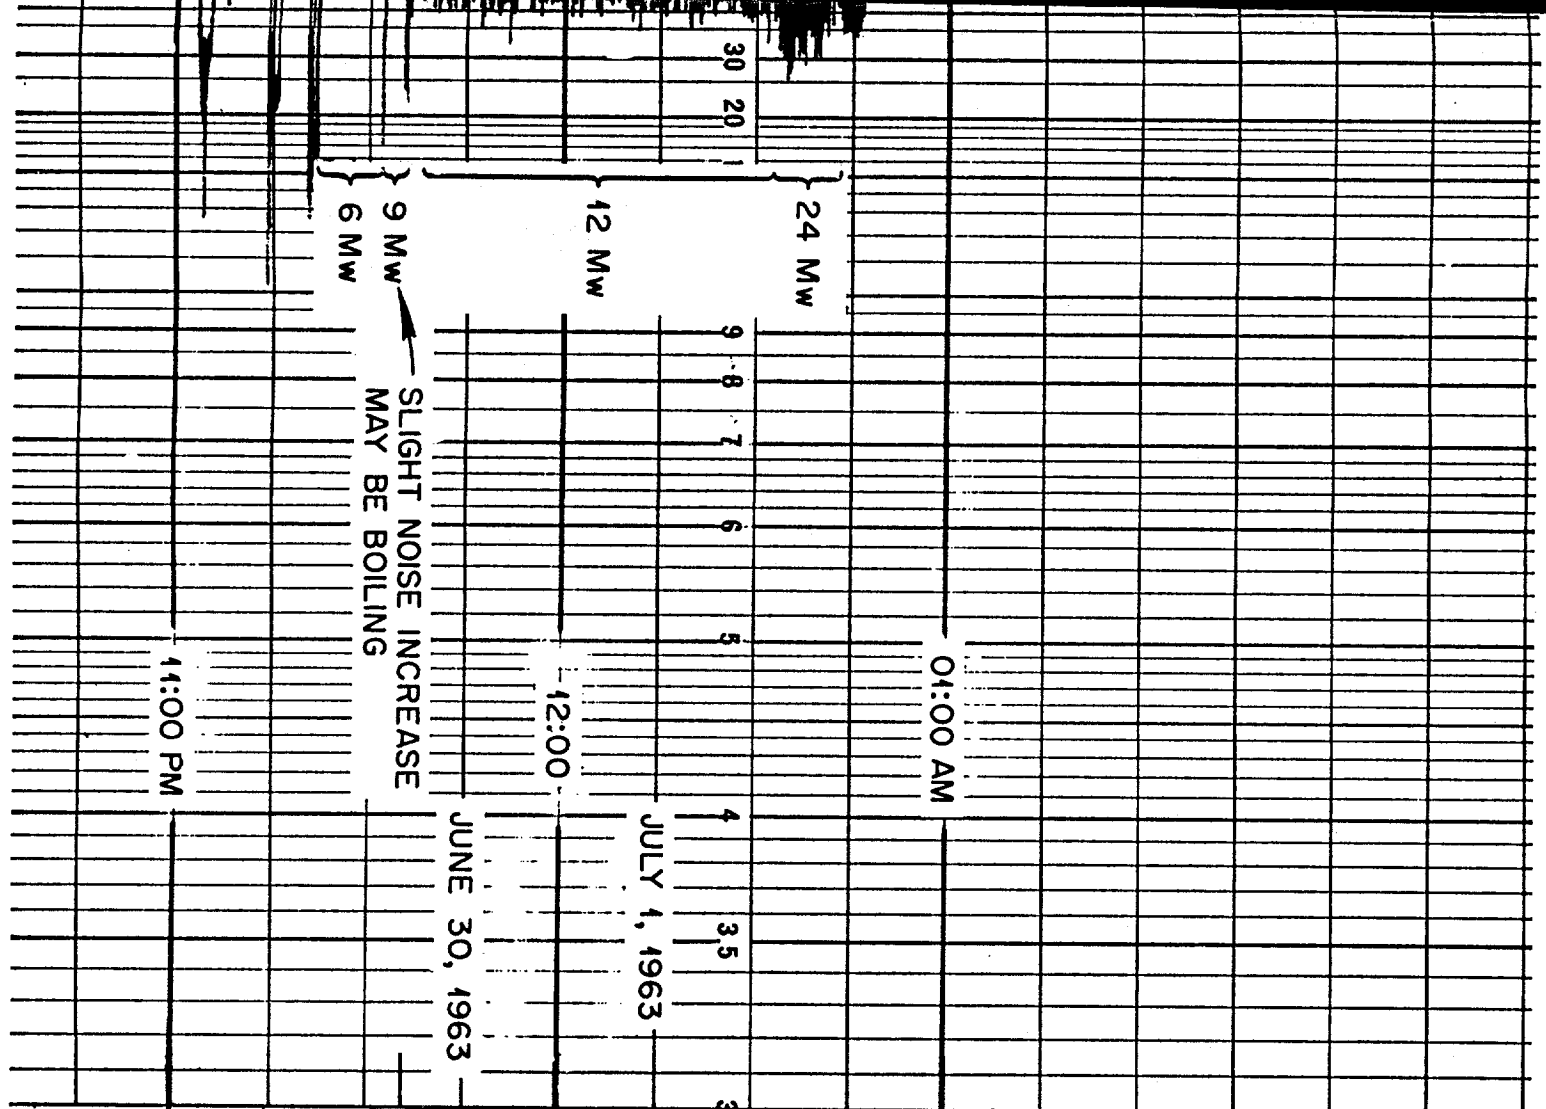
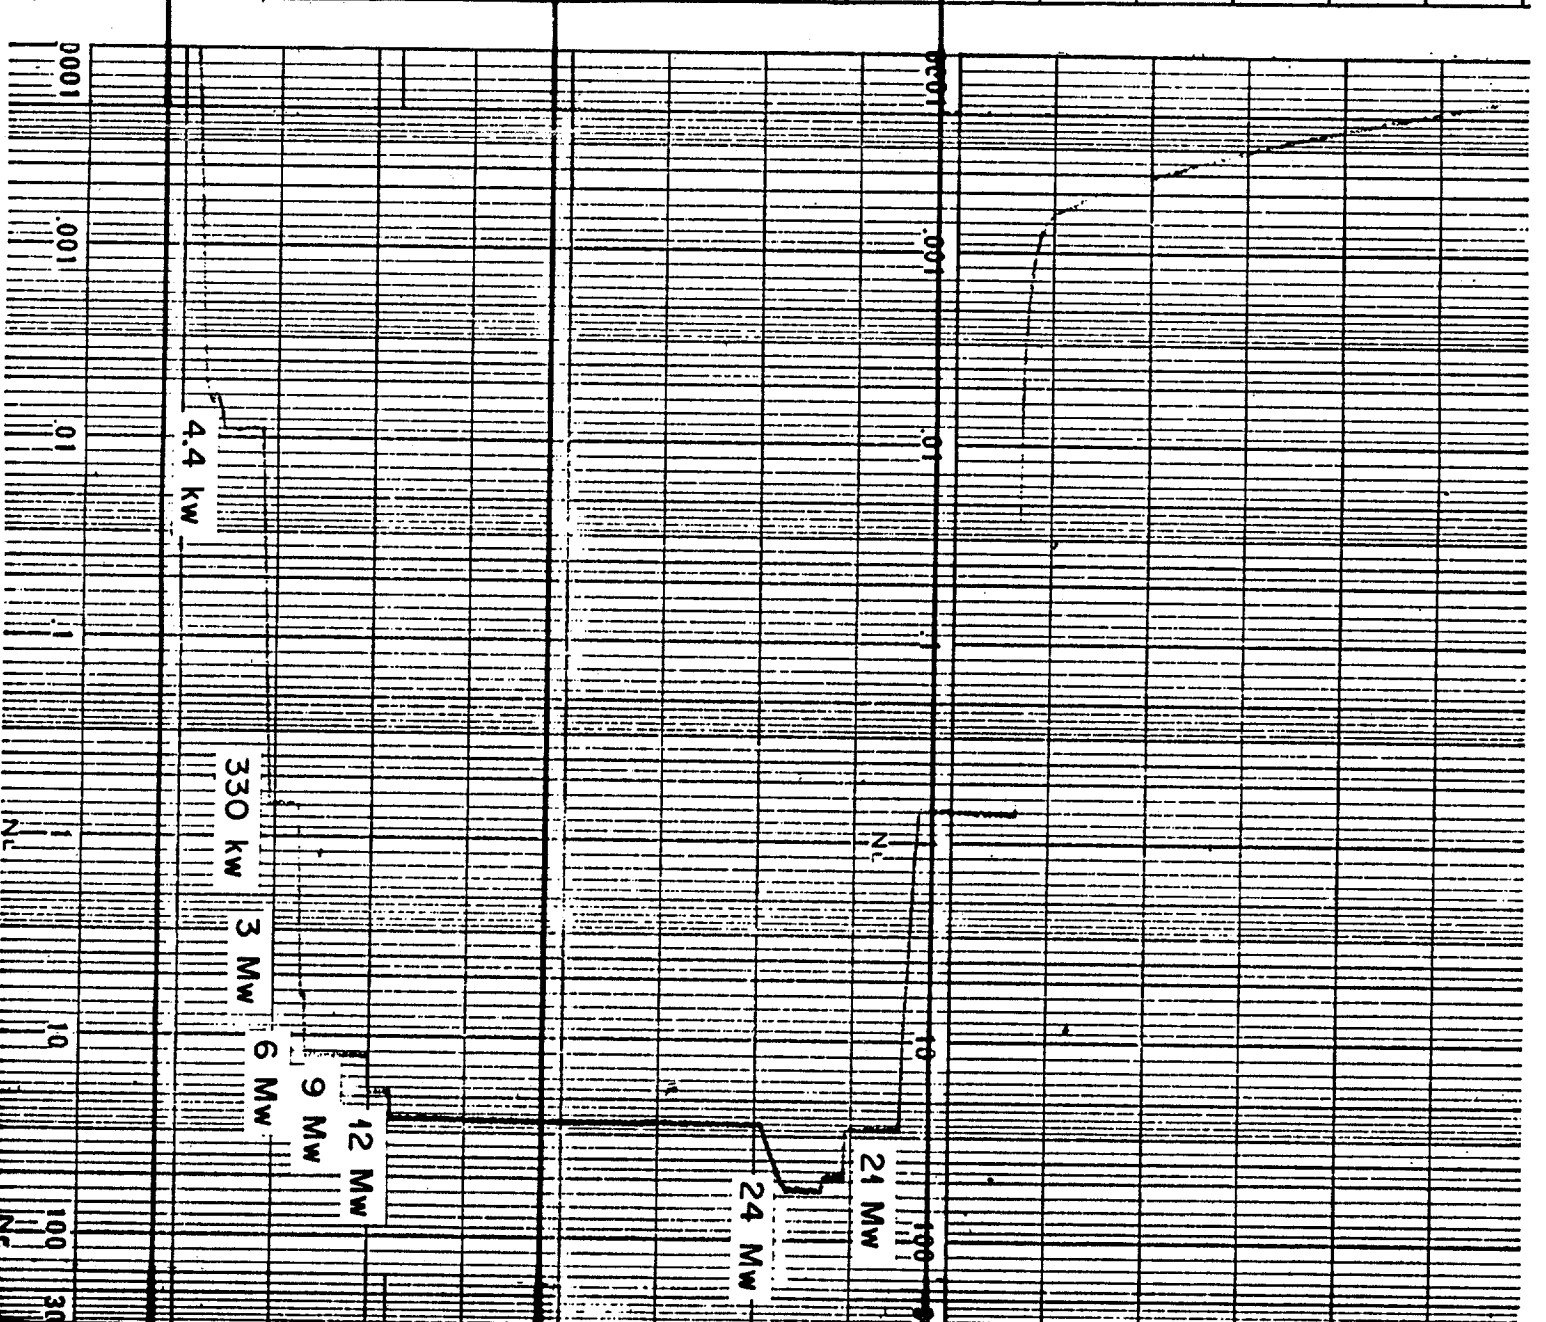
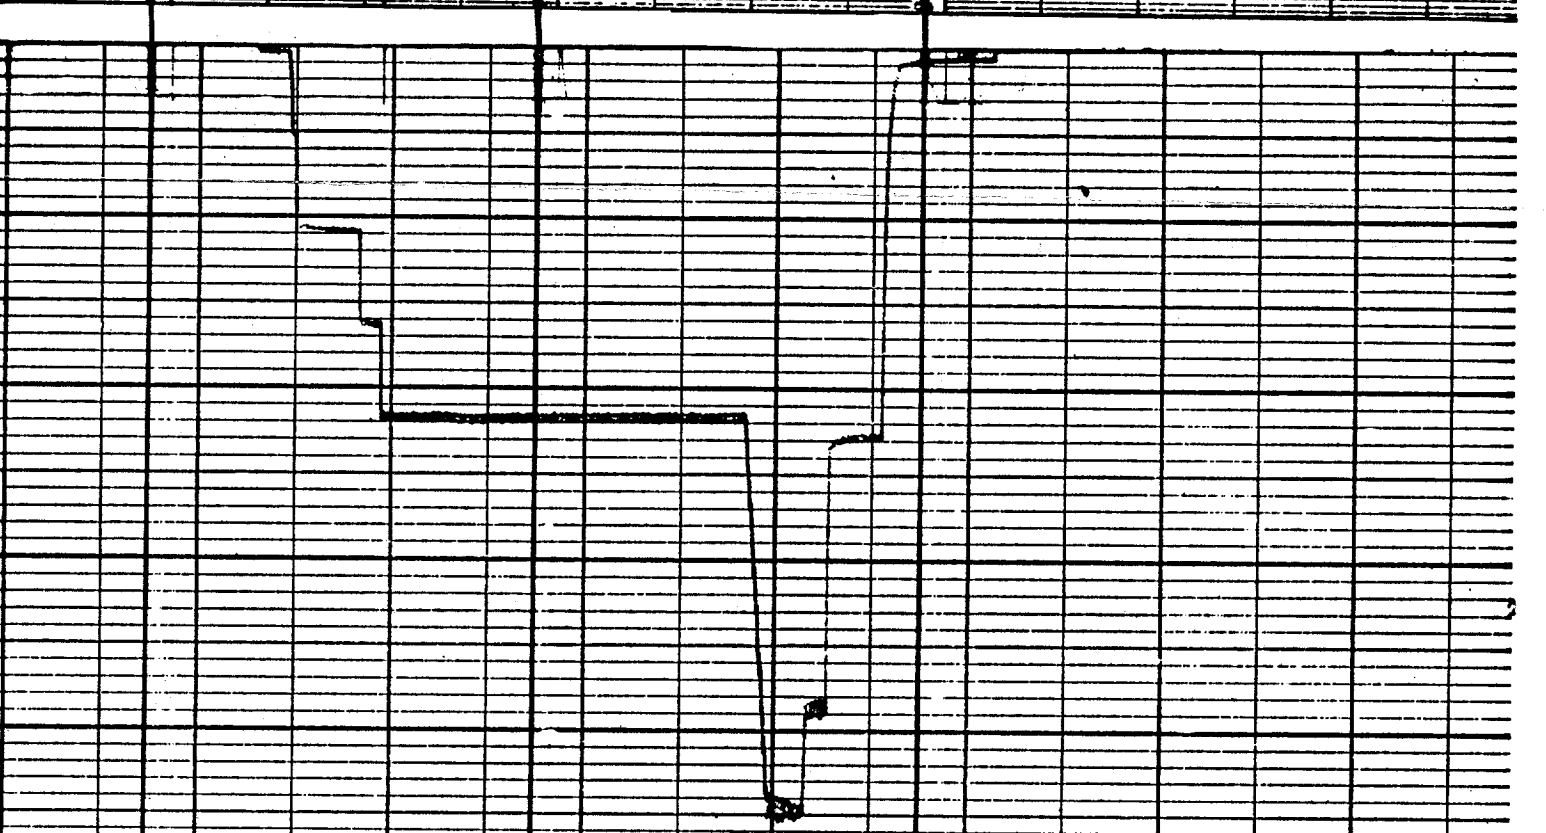
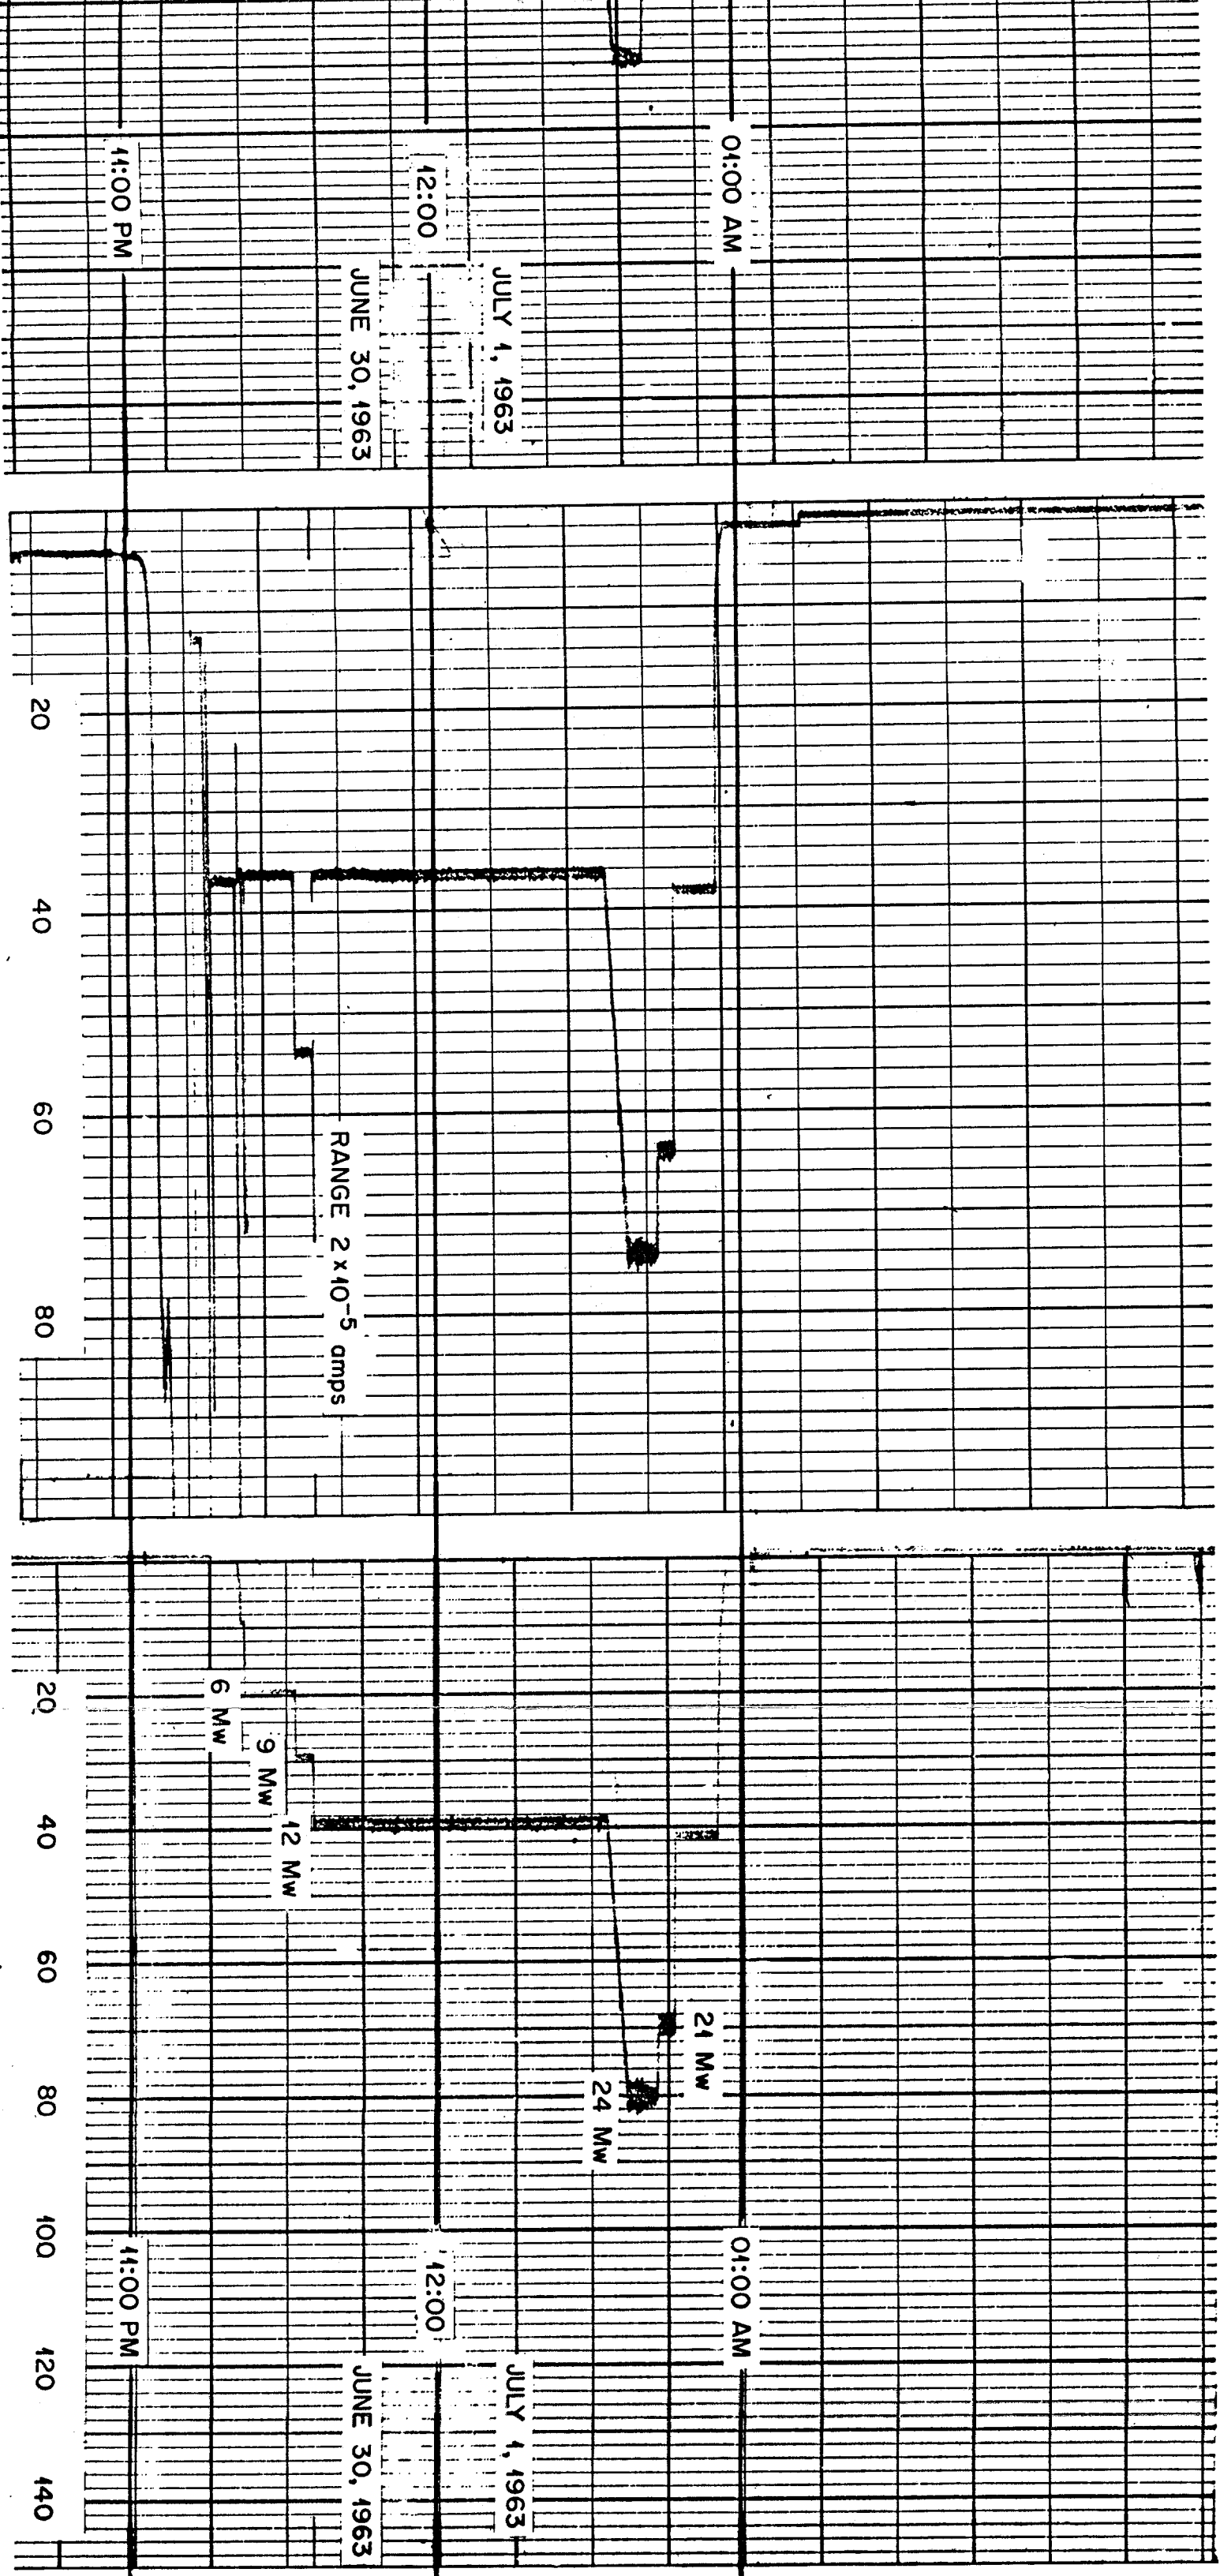
Fig. 1. Nuclear Instruments Recorder Charts from 10:30 PM, June 30, 1963, to 02:30 AM, July 1, 1963

Figures 1 and 2 display the recorder charts from the main control and safety instruments. These records were synchronized to facilitate their interpretation. For comparison, two recorder charts from a previous cycle (assumed to be normal) are also shown.

The reactor shim-rods withdrawal was started at 10:35 PM, June 30, 1963. The source level can be observed at the bottom of the No. 1 count-rate-meter chart. The log-N records indicate that the reactor power was stabilized for a few minutes at various levels: 4.4 kw, 330 kw (N_L), and 3, 6, 9, 12, and 24 Mw.

At the 9-Mw step, everything seemed normal although postincident examination of the log-N period and safety channel charts indicates a slight increase of the reactor noise. This observation is interesting because, if one assumes that the blocked element started to boil at about 9 Mw, it indicates that it took an increase of a factor of 2.7 in power to damage the element. Accounting for possible variations in coolant flow, this corresponds quite well with heat-transfer predictions.

The power was then increased to 12 Mw, and there all instruments indicated some fluctuations. The servo system was also working harder than usual. These indications could only lead to two conclusions. The first is that the servo was out of adjustment and, therefore, excited the reactor; the second is that the reactor was noisier than usual and that the servo was trying to control the fluctuations. It would, of course, have been possible to decide between these two alternatives by putting the reactor in manual operation. If the noise remained, it could be concluded that the reactor fluctuated more than normally; if it vanished, the servo would have been at fault.

It is worth noticing that the noise amplitude at 24 Mw, as shown by the two safety channel and the gamma chamber charts, remained constant during the first three minutes of the run and then decreased steadily. The various radioactivity monitors (see Figure 4) also indicate that the activity was released during the first two or three minutes of the 24-Mw run. Subsequent inspection of the fuel plates of the damaged element showed that only one plate melted, and it is possible that this occurred in a short time following which the melting stopped and the boiling which caused noise in the instruments became less severe.

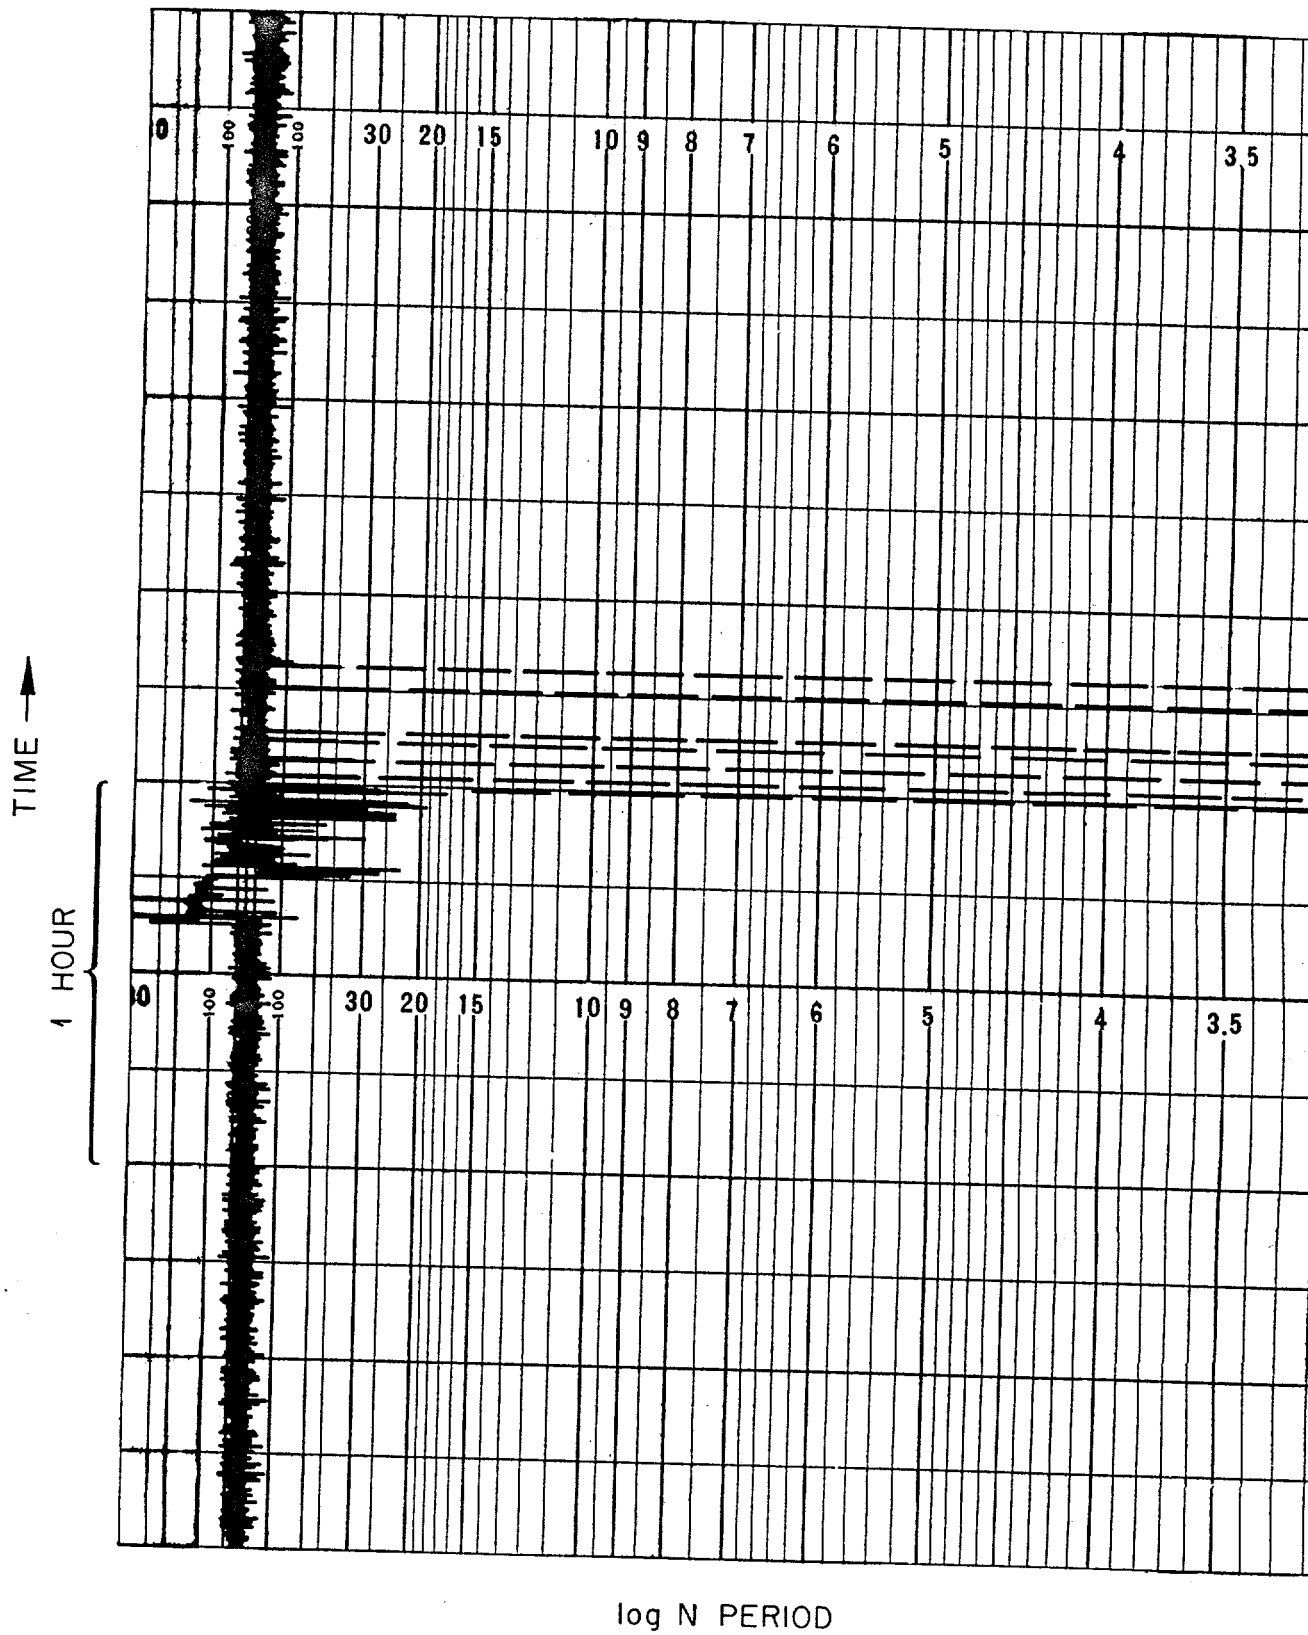
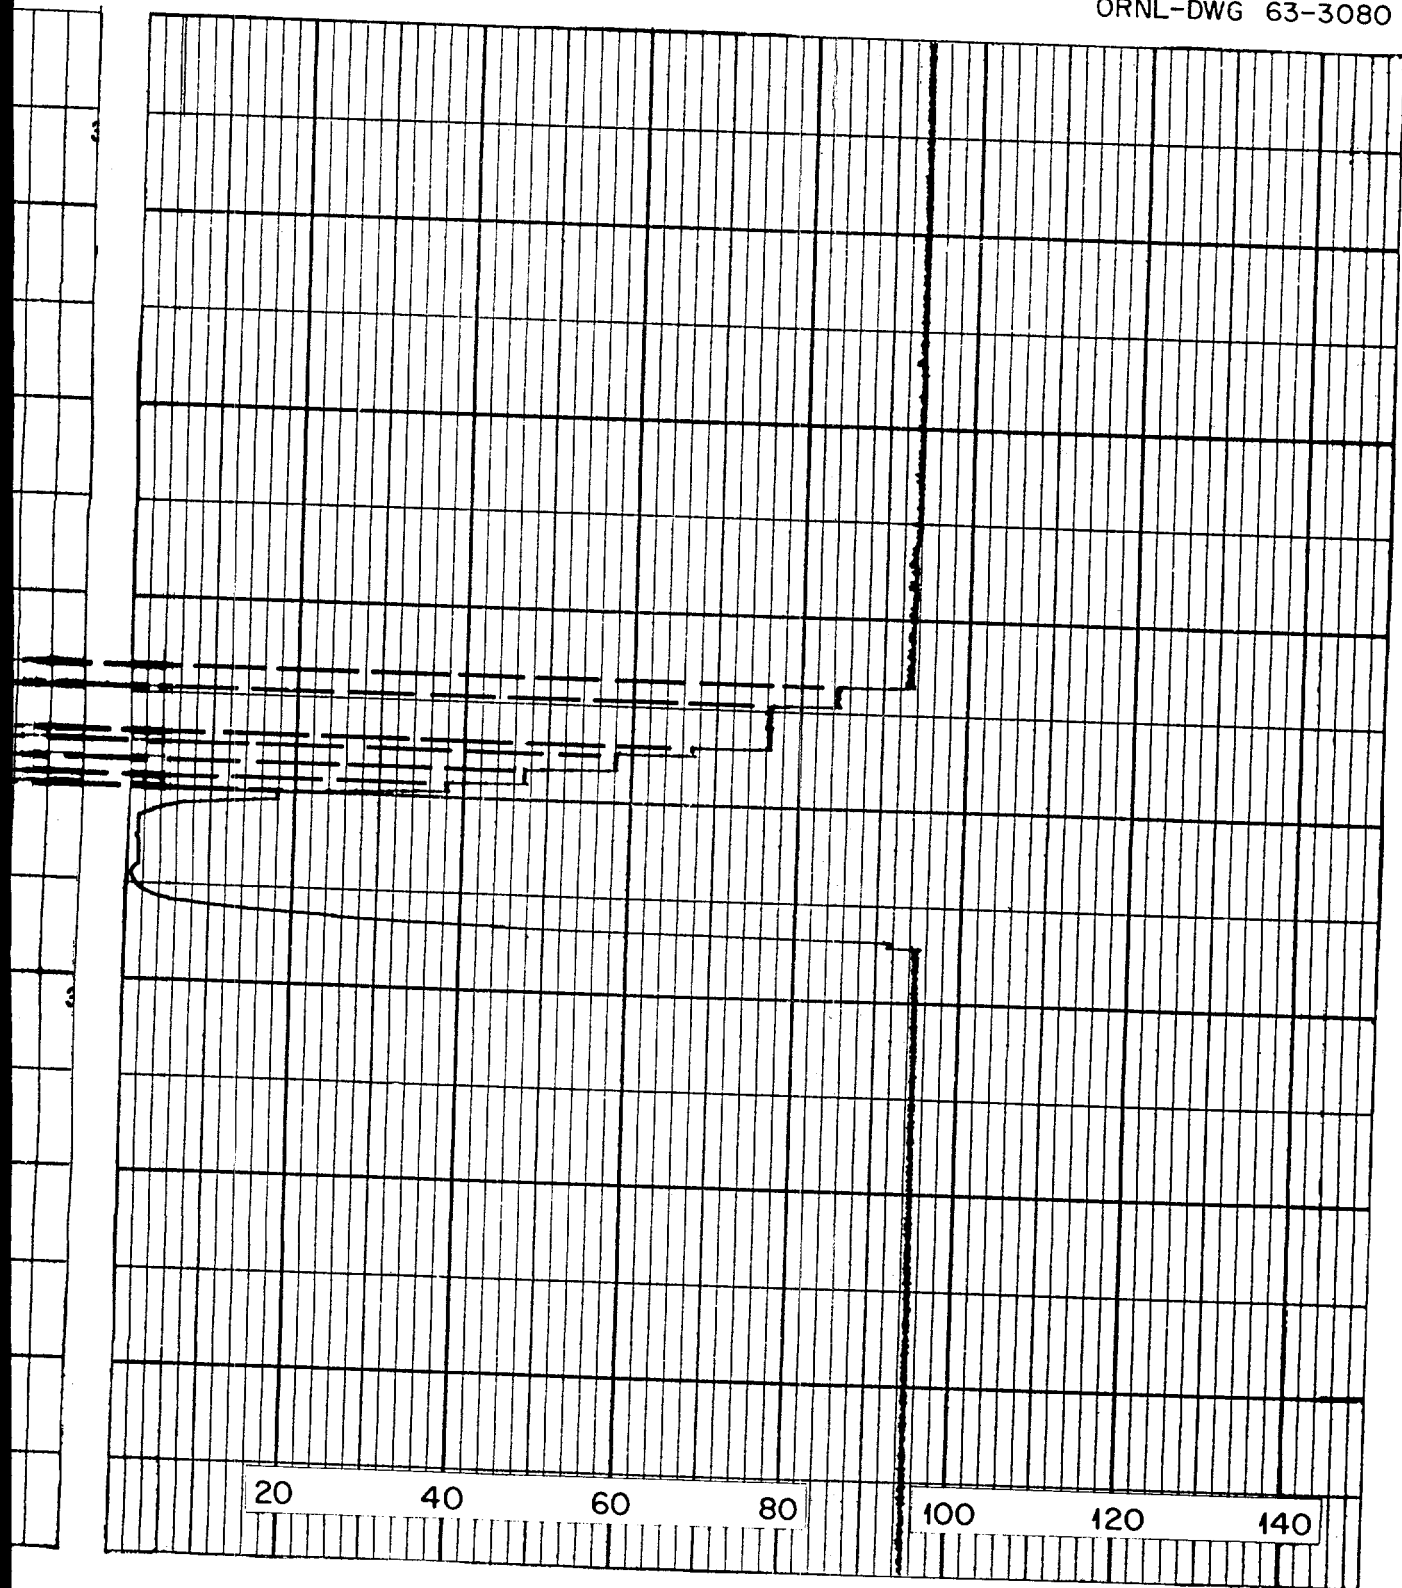
NORI
Fig. 2. Recorded

Consultation was held between the 4-12 and 12-8 shift engineers, and later a telephone consultation was held between the 12-8 shift engineer and an instrument engineer. The effect was attributed to the malfunctioning of the servo system. It must be recognized, however, that the amount of noise was not very large and that without comparing this chart with a chart from a previous cycle it is difficult to decide if the condition is really very abnormal.
